BLUE RIVER WATERSHED GROUP

Blue River Integrated Water Management Plan
Phase I Report

BLUE RIVER IWMP

Integrated Water Management Plan

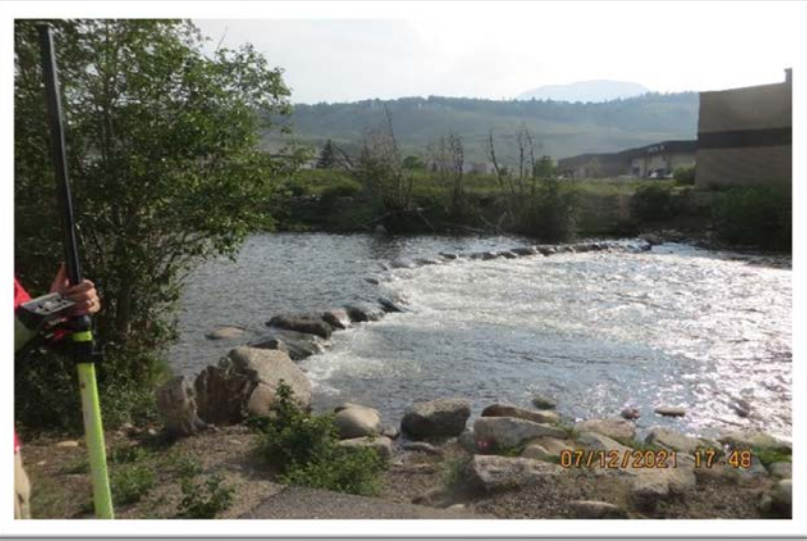
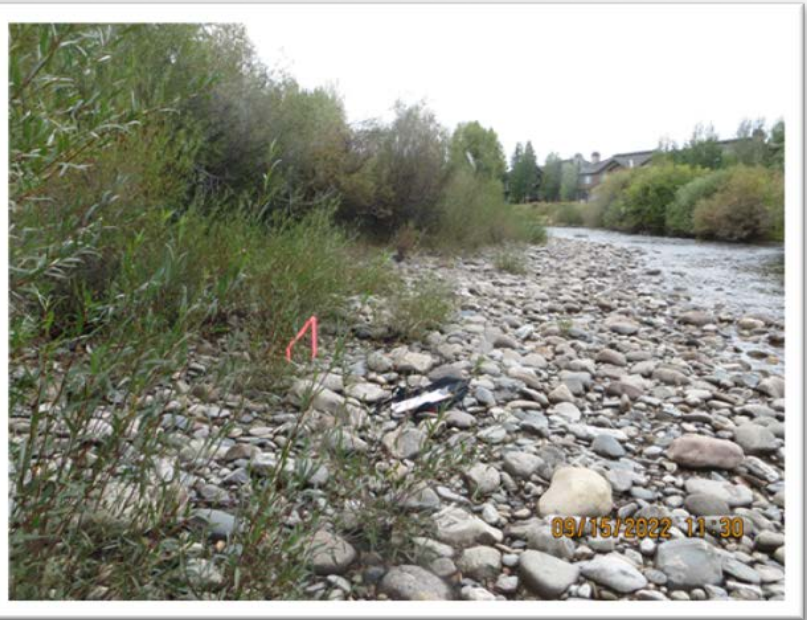
- Summary of Findings-

- **Pool habitat is greatly lacking.** Existing pools are at minimum depths and are not on outside bends
- Roughly 95% of the river has **no cover** (riparian or rock structure)
- **Lack of spawning gravels.** Substrate is dominated by cobble and boulders with gravel material being provided by tributaries further downstream
- Flows are dominated by required **minimum flows** (50 cfs can be expected to 80% of the time)
- Macroinvertebrates generally lack diversity and mass in the upper reaches
- Periphyton generally lack diversity in the upper reaches
- Dam impacted **water temperatures** roughly match inflow temperatures by the USFS Blue River Campground

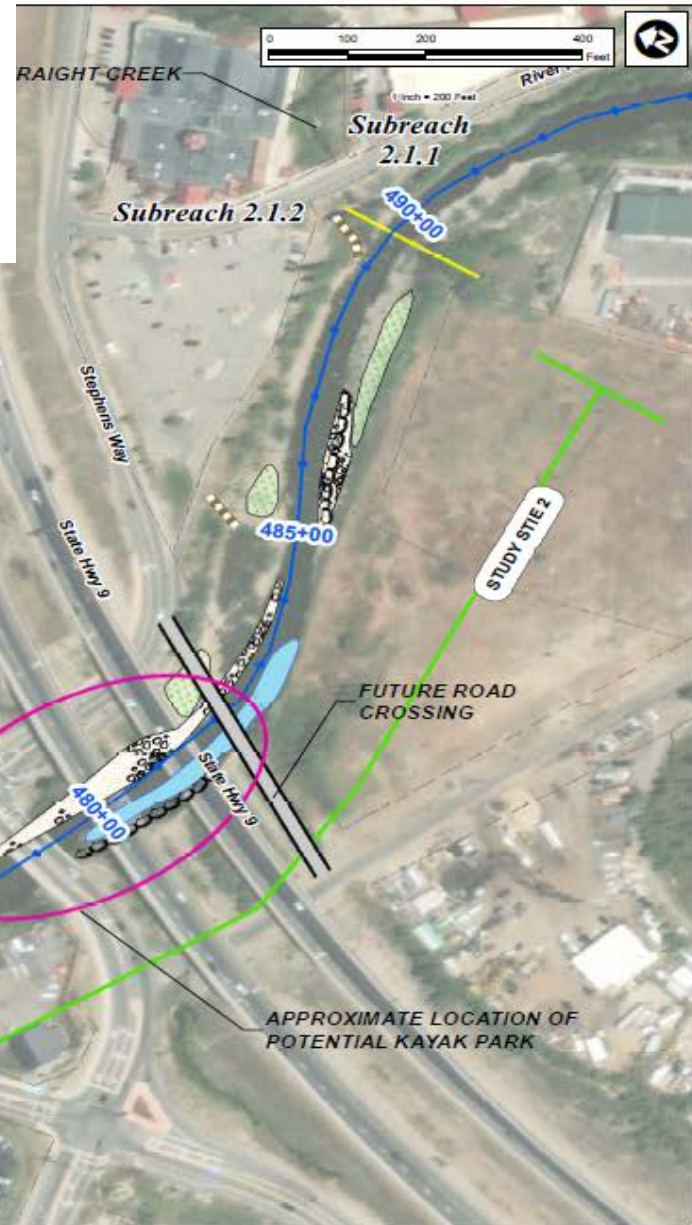
Integrated Water Management Plan - Restoration Concept Plan-

March 2023	
		Blue River Conceptual Restoration Master Plan	SHEET
		Blue River Integrated Water Management	2
		Summit County, CO

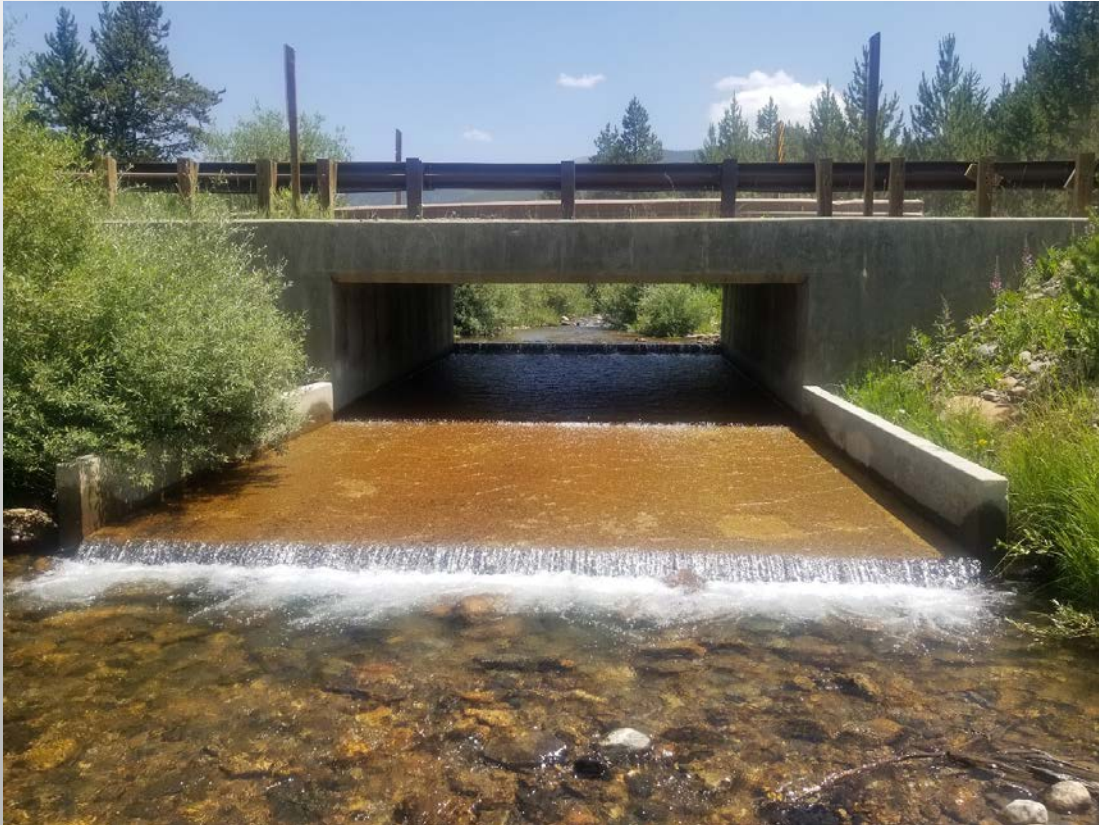
As restoration work moves up-valley, a Cutthroat population on the N Swan is at risk for increased pressure by invasives.

Ineffective Current Velocity Barrier

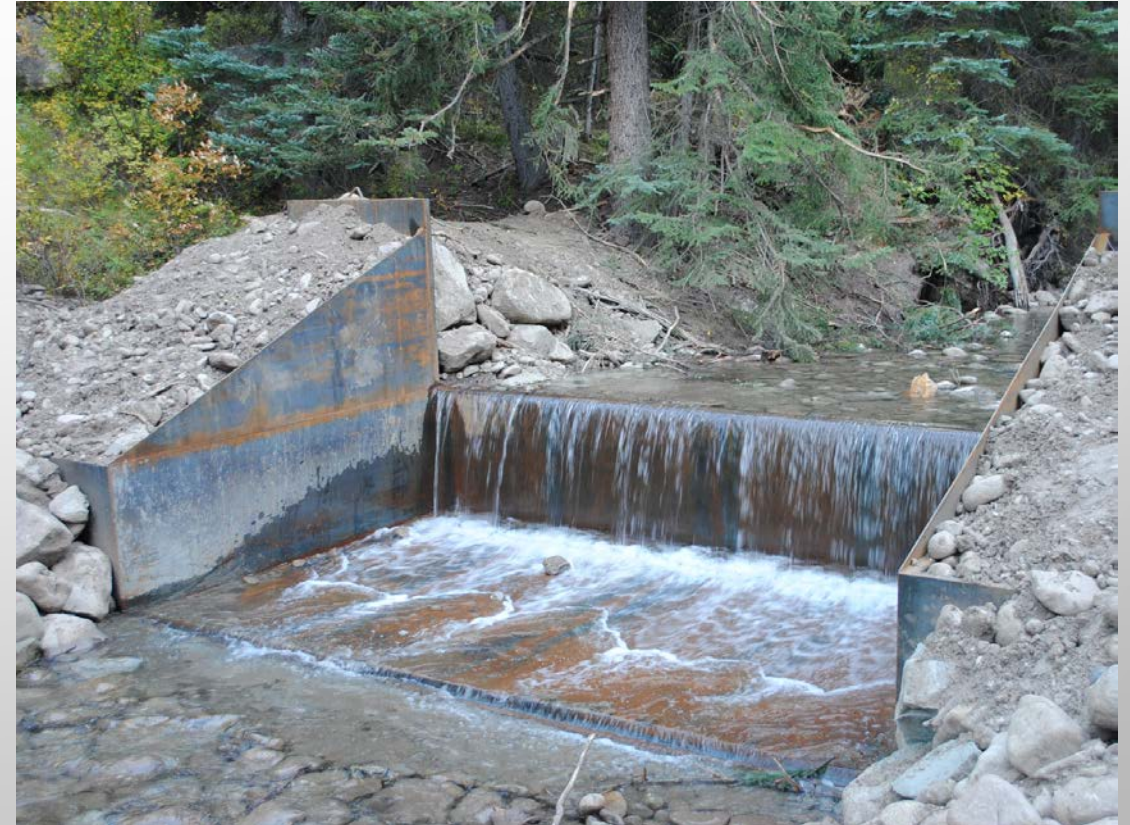
Proposed New Structure
